# Manhole Inspection Summary

Manhole # S290\_\_019MH

Insp Date: **5/14/09 9:15 AM**

**Location** Address: **1099 SCOTT ST**

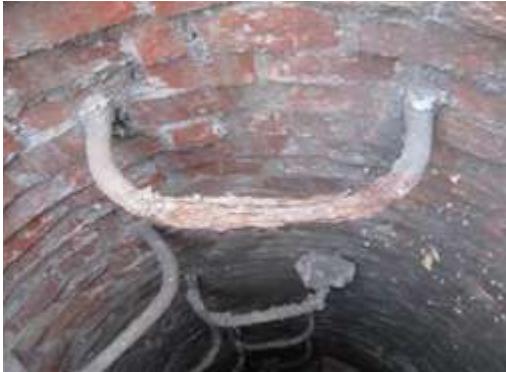
Defect 3

**Steps** Count: **8** Missing: **0** ☒ **Corroded**

CORRODED RUNG

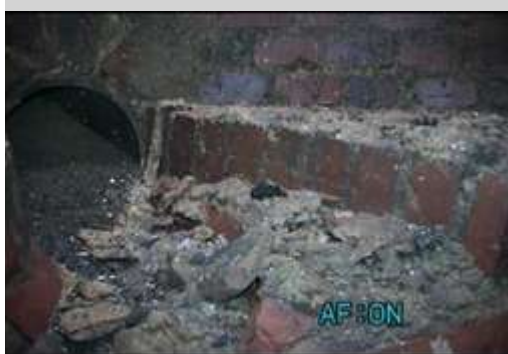
### Defect 1

Condition: ☐ Sound ☐ Cracked ☐ Root Intrusion ☐ Deteriorated ☐ Leaks ☒ **Debris**

DEBRIS IN CHANNEL AND ON BENCH

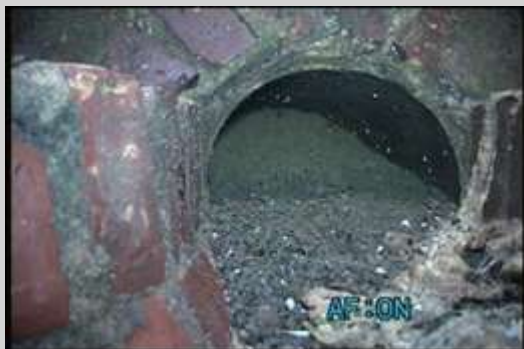
2 O'Clock Inflow

Pipe Height: **8.4** (in.) Rod and Bar (Angled)  
Pipe Material: **Clay** ☐ Pipe Lined  
Invert Depth: **11.49** (ft.) Flow Characteristics: **None**  
Deposits: ☐ None ☒ **Mud** ☐ Sludge ☐ Debris ☐ Grease  
Silt Depth: **4** (in.) Deposits Extent: **Medium**  
Infiltration: **None** Pipe Seal Cond: **Sound**
